SCIENTIFIC ELECTRONIC PRODUCTS, INC.
FINAL REPORT
RELIABILITY STUDY OF HC-27/U HOLDER
CONTRACT NO. DA-36-039-SC-87456
TASK NO. 3A-99-15-007-01
PLACED BY U. S. ARMY
SIGNAL RESEARCH & DEVELOPMENT LABORATORY
FORT MONMOUTH, NEW JERSEY

RELIABILITY STUDY
OF
HOLDER HC-27/U

1 July 1961 to 30 December 1962

FINAL REPORT

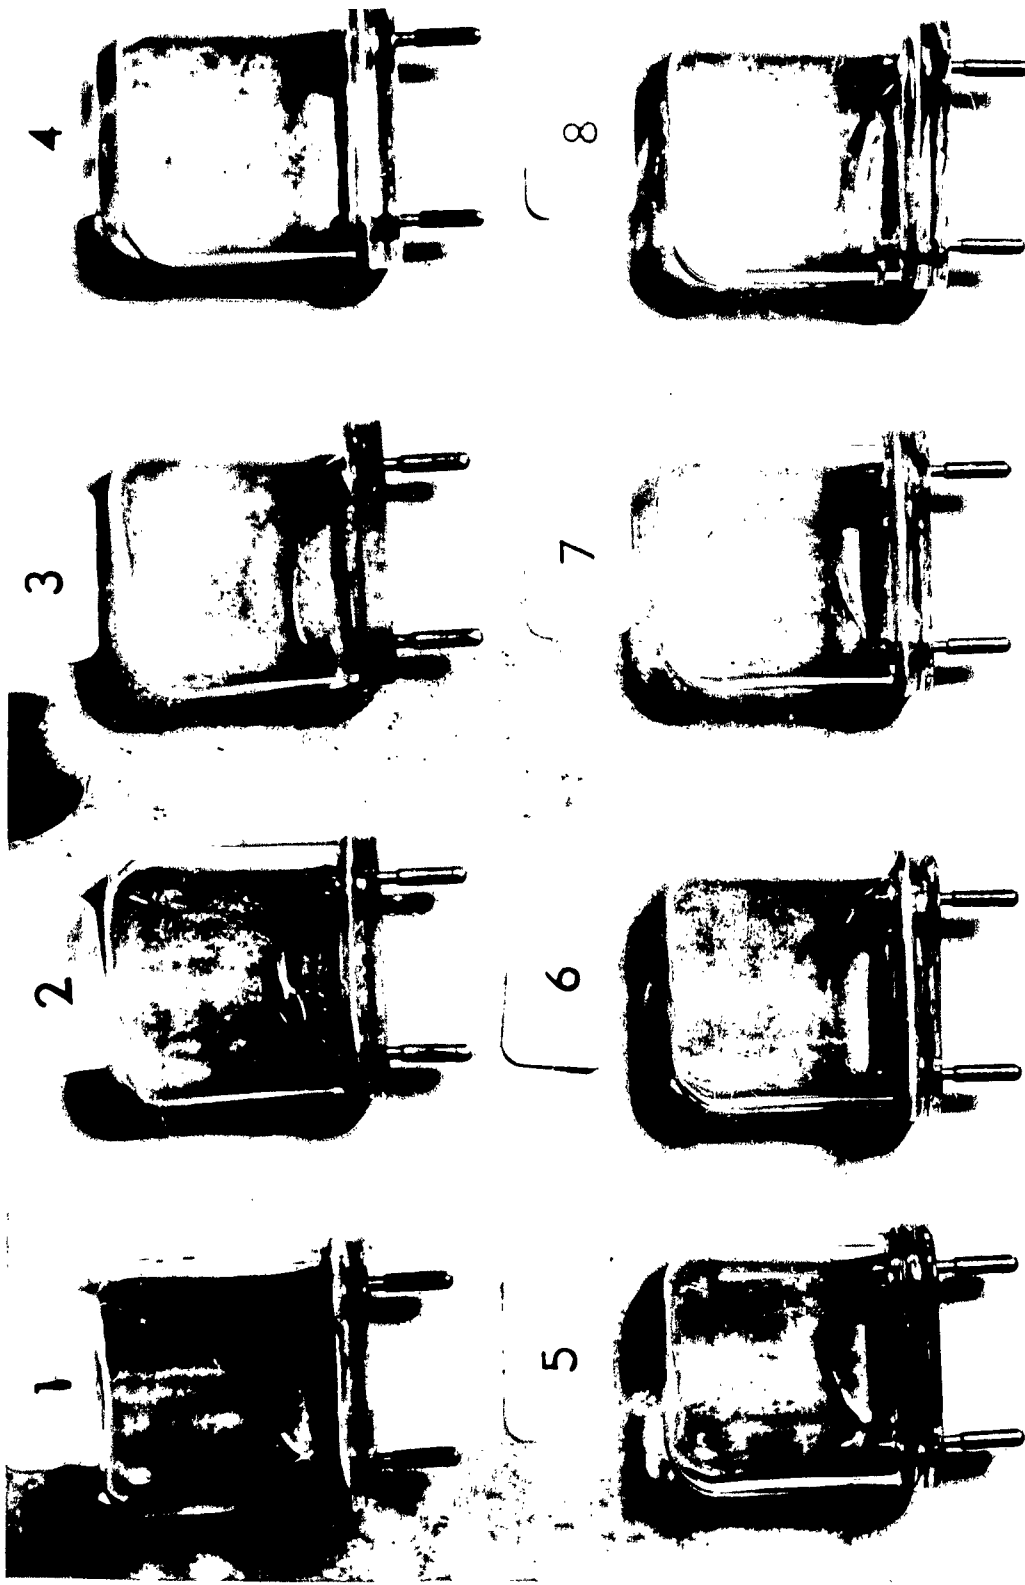
Fig 7

FIGURE 7: Holders number 1, 2, 3, 5, 6, 7 and 8, show cracked holders due to poorly aligned parts, covers too large, and too much frit.

Holder number 4 appears to be a good seal but lost vacuum possibly because of too much frit or leaking around the pins.
